DESIGN, FABRICATION, TEST, AND EVALUATION OF A **PROTOTYPE 150-FOOT LONG COMPOSITE WIND TURBINE BLADE**

Herbert W. Gewehr Kaman Aerospace Corporation

September 1979

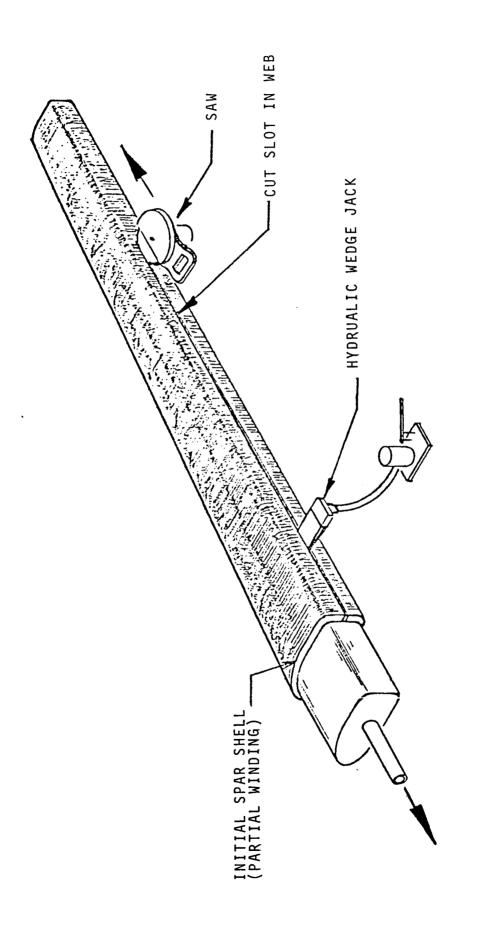
Figure 61. Freeing the Half-inch Spar Shell From the Mandrel.

The intermediate step of winding and curing the half-inch spar wall was used in the winding process to insure that the mandrel could be removed after the spar was completed. Mandrel extraction after stage two was attempted by direct force application at the blade root. A force of approximately 300,000 pounds was applied at the root end (estimated via torque applied to bolts around the bucking ring), which was the maximum force that could be applied with existing equipment. It was not possible to effect mandrel extraction at this force level, so a pre-planned backup extraction procedure was implemented. This consisted of slitting the aft vertical web of the half-inch shell and prying the shell away from the mandrel, as illustrated in Figure 61. The axial force at the root end was maintained as the shell was slit and pried open from the tip toward the blade root. When the slit had been extended inboard to station 55, the spar shell became loose, so further slitting was avoided. The aft web of the spar shell was repaired with a fiberglass wet layup, as illustrated in Figure 62, and cured. Finally, in stages three and four, the inboard and the outboard lengths of spar were wound to full wall thickness which included a ten-foot scarf joint. Mandrel extraction, following completion of step four, was readily effected. Typical views of the spar winding operation are shown in Figures 63 and 64.

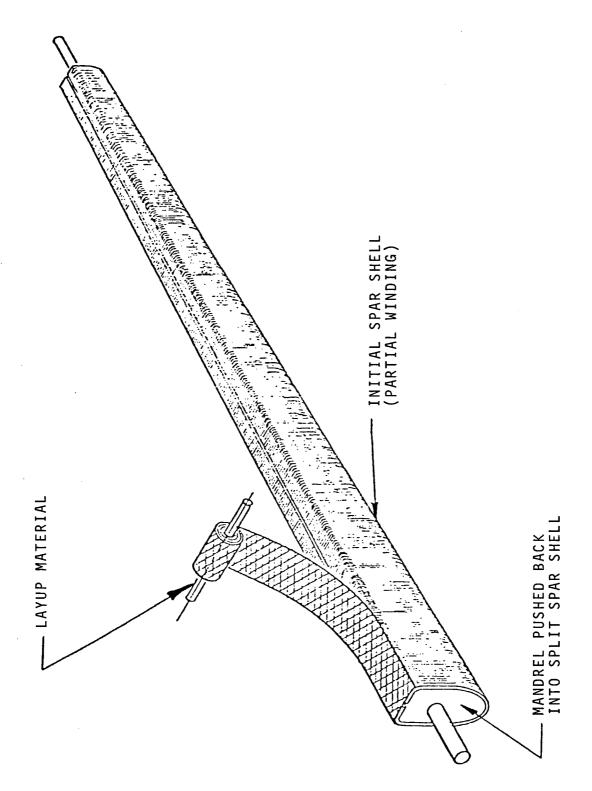
Figure 62. Repair of Spar Shell Aft Web.

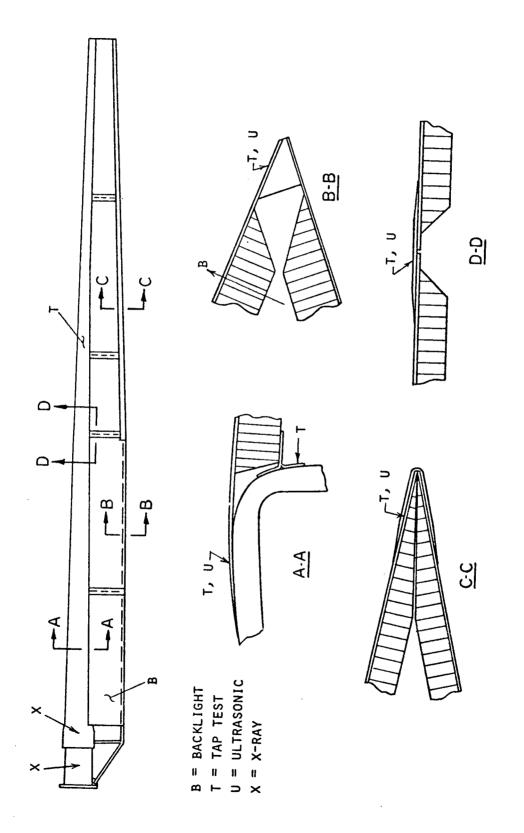
Figure 71. Typical Non-destructive Inspection Procedures Along Blade.

Tap testing is a useful inspection technique for detection of voids and delaminations near the surface of a laminate, and in assembly bondlines, but it is not effective for detection of such defects within a thick laminate. Ultrasonic inspection provides the necessary capability, if required.

Testing by X-ray is costly and, therefore, not as production applicable as ultrasonic inspection. However, X-ray may be useful for examination of specific localized areas, such as the root end. X-ray examinations of heavy wall sections up to three inches were made and were found to reveal fiber orientation and void conditions.

For the afterbody section, quality assurance involved both the panel subassemblies and the final assembly of panels to the spar. Tap testing and visual examination are the basic techniques that were employed on completed assemblies. Ultrasonic testing, or X-ray, can be used on suspect areas requiring further examination. Typical inspection procedures appropriate for various areas of the completed blade are illustrated in Figure 71, and listed in Table 7.

One of the significant advantages of composite structures is their repairability, even for thick sections, by conventional, well established methods. Typical repair procedures are listed in Table 8. This feature, along with established NDI methods, gives early promise that adequate quality assurance can be readily effected for large wind turbine blades.

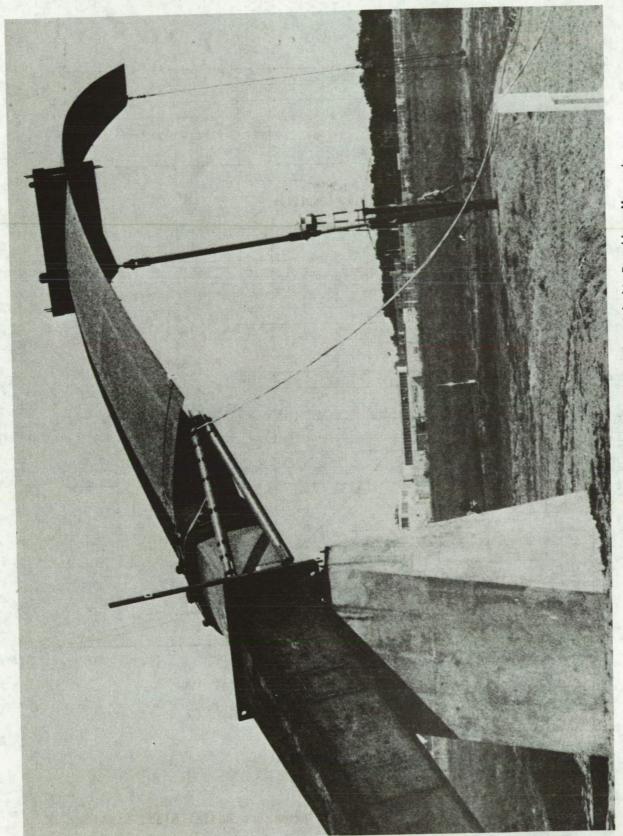
Figure 80. Flatwise Deflection at 100% Design Limit Bending Moment.

After completion of the natural frequency and stiffness determinations, and the edgewise test to design limit load, the blade was repositioned as shown in Figure 79 for the flatwise tests. The blade was tested to design limit load in the flatwise direction, Figure 80, and then taken to failure which occurred at 9 percent above design limit load, Figure 81. Failure occurred at blade station 45, Figures 82 and 83, as local crippling at a flaw in the spar laminate. Although the flaw was detected in the surface of the spar during the NDI process, its effect on crippling strength was not recognized. Subsequent investigation revealed that the flaw was a local bulge in 60 percent of the spar wall thickness, resulting from the four step winding process and the associated soft tooling. Future blades will be made in a single step with improved tooling to eliminate such flaws.

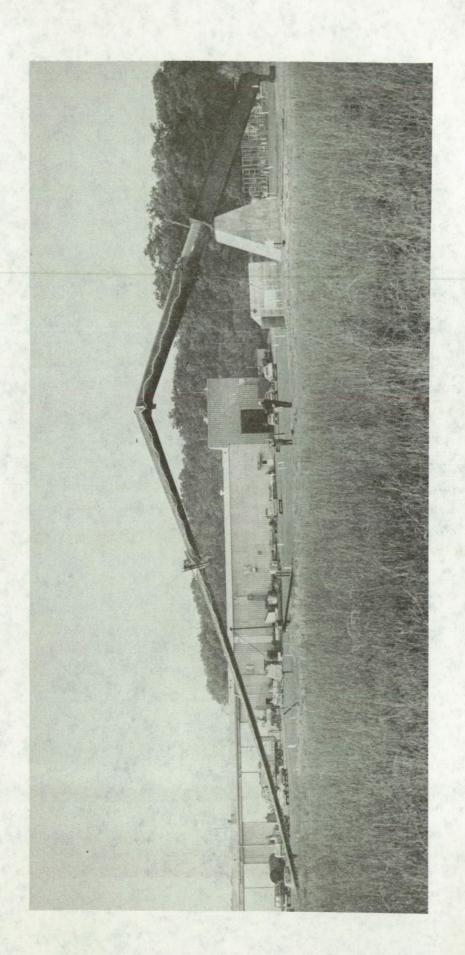
Figure 82. 150 Foot Blade After Failing Load Test.

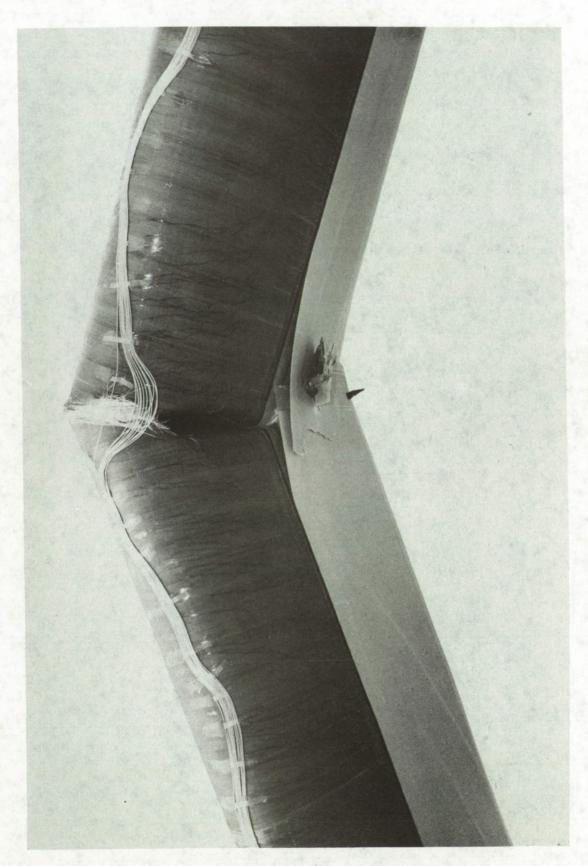
Figure 83. Crippling Failure of Blade Spar.

This test demonstrated that large knockdown factors from theoretical crippling strength predictions are not necessary for pure monocoque glass/epoxy structures of this type, provided no serious material defects (such as the local bulges present at the station 45 failure location) are present.

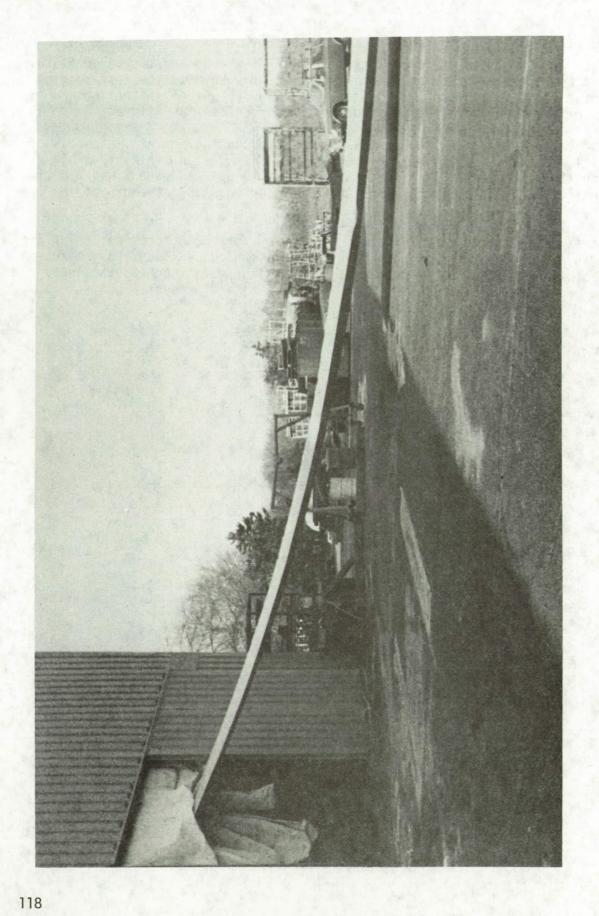
Blade Deflection at Approximately 15,000 Pounds Tip Load, Second Buckling Test. Figure 84.

Subsequent to the ultimate load test of the complete blade, the outboard 100 ft of blade was still structurally intact, so it was set up and tested in flatwise bending as a simply-supported overhanging beam, Figure 84. The test section from station 90 to 150 had none of the local flaws observed in the inboard region of the spar where the previous test had resulted in failure.

The outboard test section successfully sustained bending moments in excess of the ultimate design condition (defined as 1.5 times design limit) from blade station 106 to the tip. At blade station 130, the applied moment was 2.8 times design limit, Figure 85, well above the predicted buckling strength of the spar wall.
